Appendix E

Geosynthetics QA/QC Information

Project: **Upland LF - Northwin LF Phase 1 East**

NORTHWIN LANDFILL
CAMPBELL RIVER, B.C. – 2021
EFFLUENT POND AND LANDFILL CELL#1

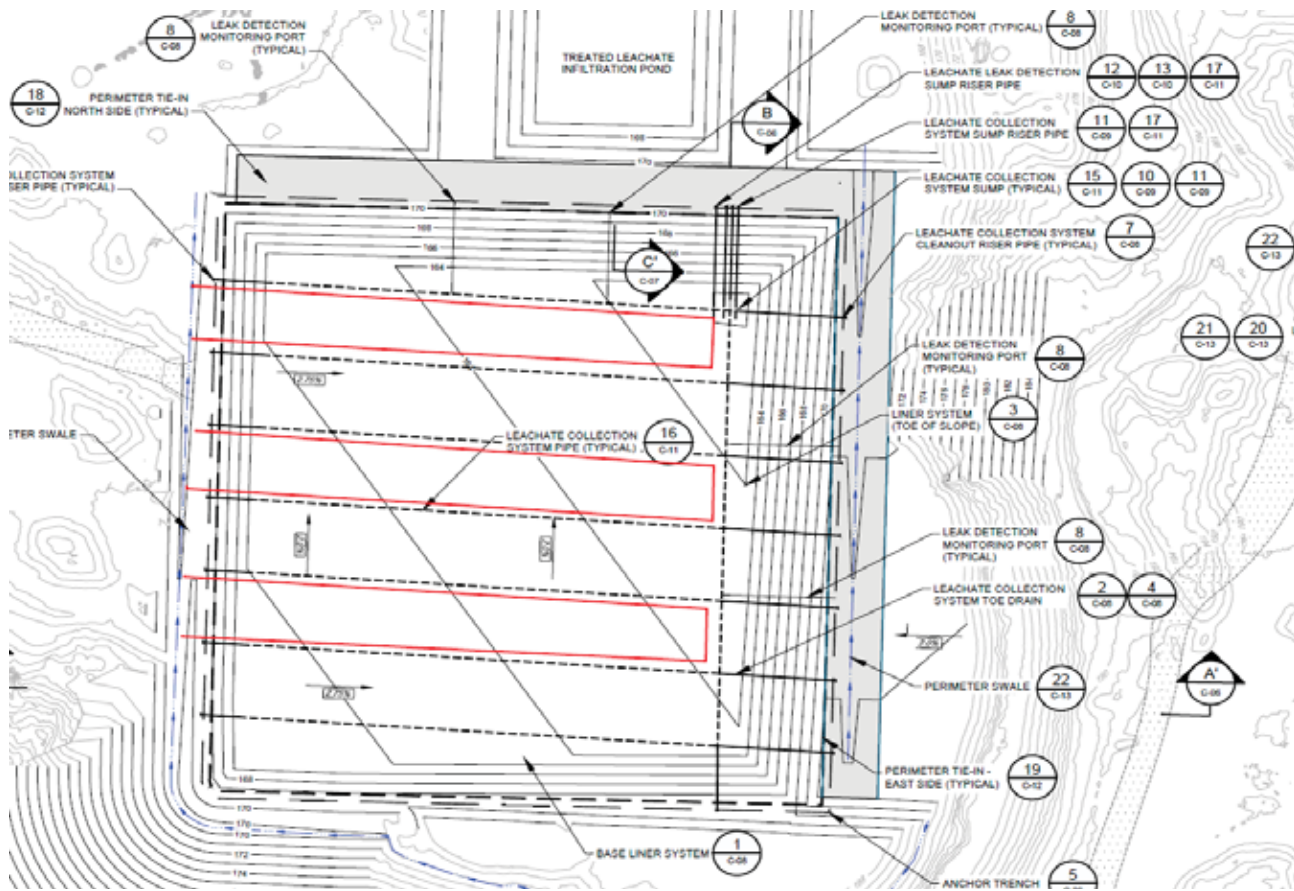
Planned location of three 1 m high drain rock roads.
