Appendix E

Geosynthetics QA/QC Information

Project: **Upland LF - Northwin LF Phase 1 East**

NORTHWIN LANDFILL
CAMPBELL RIVER, B.C. – 2021
EFFLUENT POND AND LANDFILL CELL#1

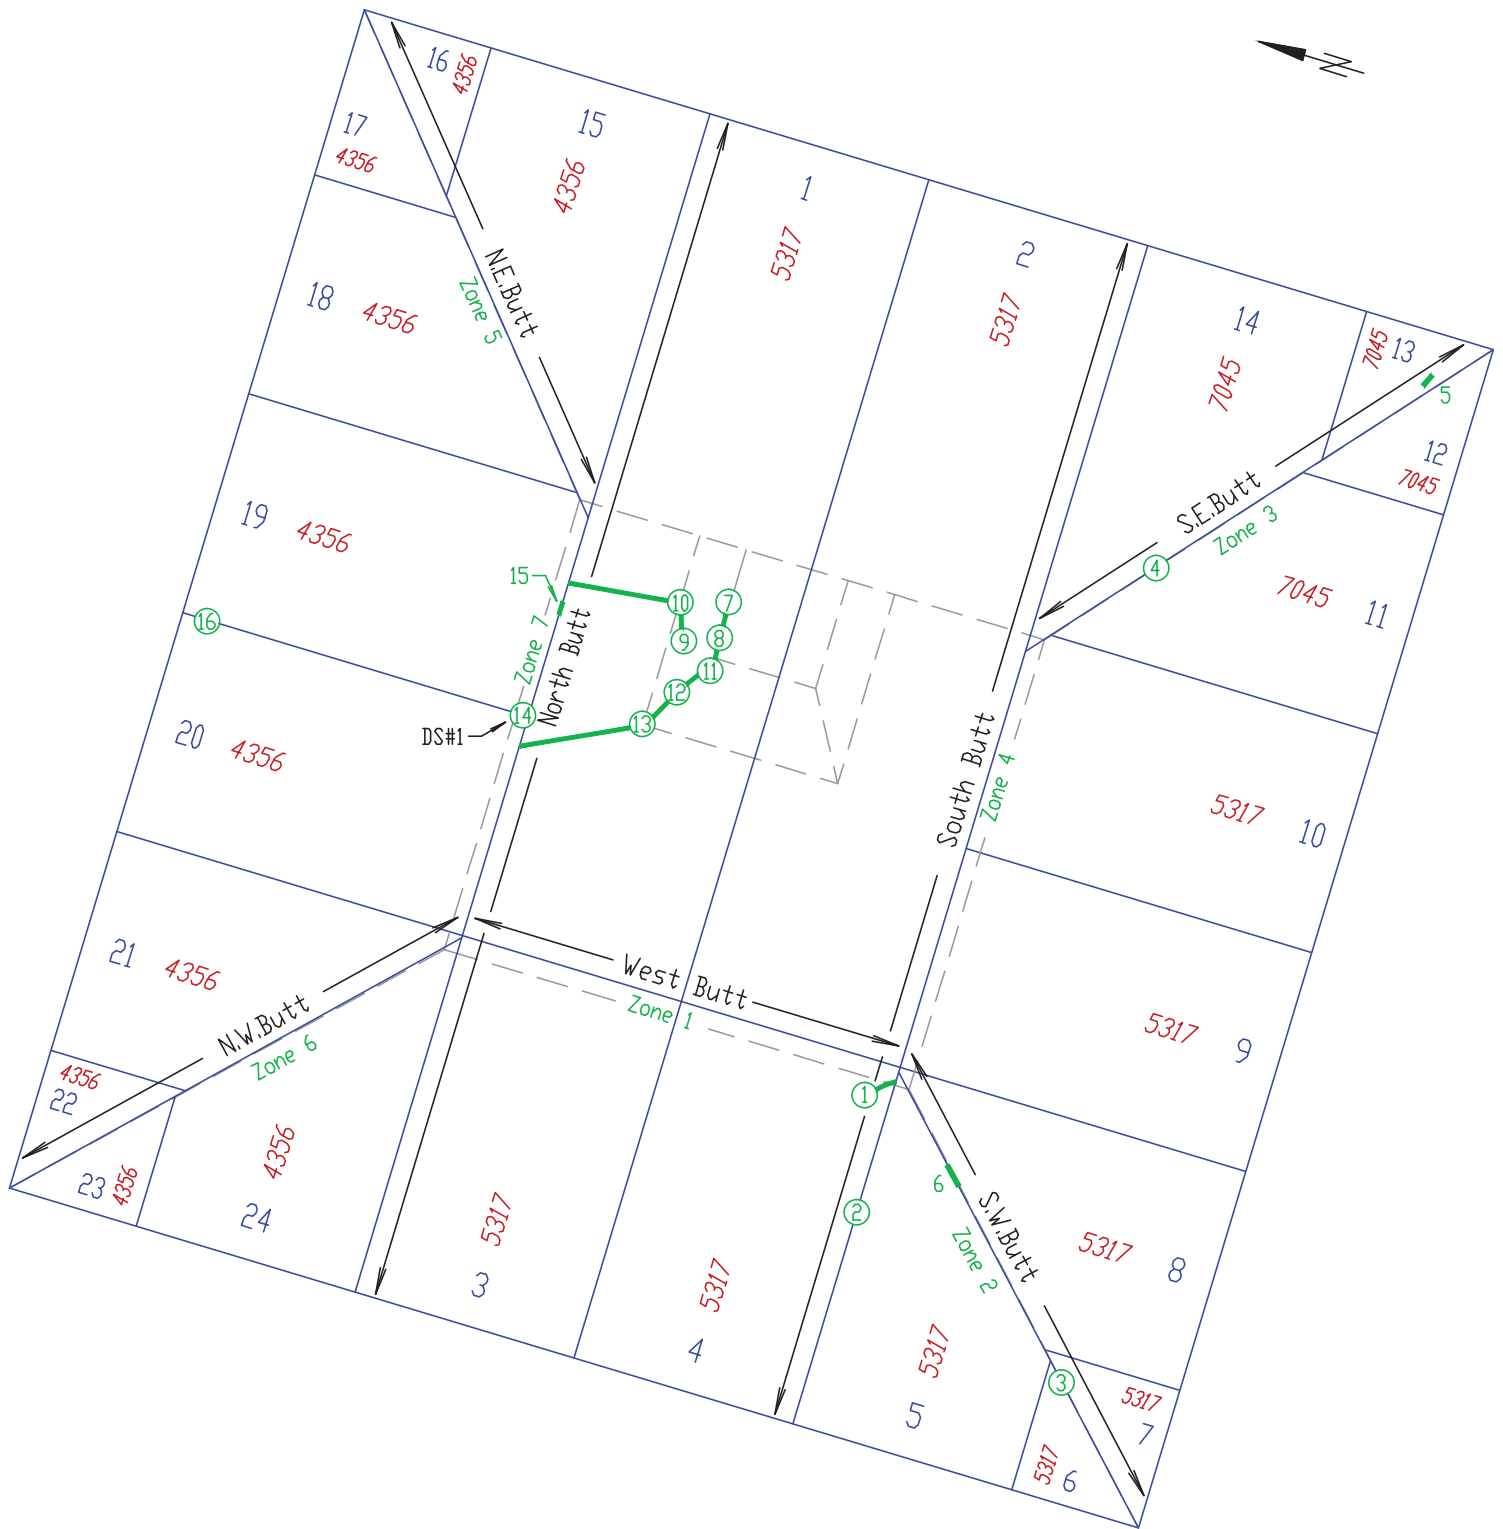
SECONDARY LINER

EXTRUSION NUMBER	EXTRUSION TYPE	PANEL/SEAM NUMBER	TEST DATE	TECH INITIAL	MACHINE NUMBER	QC INITIAL	PASS/ FAIL	COMMENTS:
Extruded August 4th								
1	Patch/Bead	4	Aug 4, 2021	JC	X2	CC	Pass	Near S.W.Toe.
2	Patch	South Butt	Aug 4, 2021	JC	X2	CC	Pass	On West Slope.
3	Patch	S.W.Butt	Aug 4, 2021	JC	X2	CC	Pass	Near top of Slope.
4	Patch	S.E.Butt	Aug 4, 2021	JC	X2	CC	Pass	On Corner Slope.
5	Bead	13	Aug 4, 2021	JC	X2	CC	Pass	Roll damage near top of slope.
6	Bead	S.W.Butt	Aug 4, 2021	JC	X2	CC	Pass	Near top of slope.
7	Patch/Bead	1	Aug 4, 2021	JC	X2	CC	Pass	Patch and Bead in Sump to remove Slack.
8	Patch/Bead	1	Aug 4, 2021	JC	X2	CC	Pass	Patch and Bead in Sump to remove Slack.
9	Patch/Bead	1	Aug 4, 2021	JC	X2	CC	Pass	Patch and Bead in Sump to remove Slack.
10	Patch/Bead	1	Aug 4, 2021	JC	X2	CC	Pass	Bead in Sump to remove Slack.
11	Patch/Bead	1	Aug 4, 2021	JC	X2	CC	Pass	Patch and Bead in Sump to remove Slack.
12	Patch/Bead	1	Aug 4, 2021	JC	X2	CC	Pass	Patch and Bead in Sump to remove Slack.

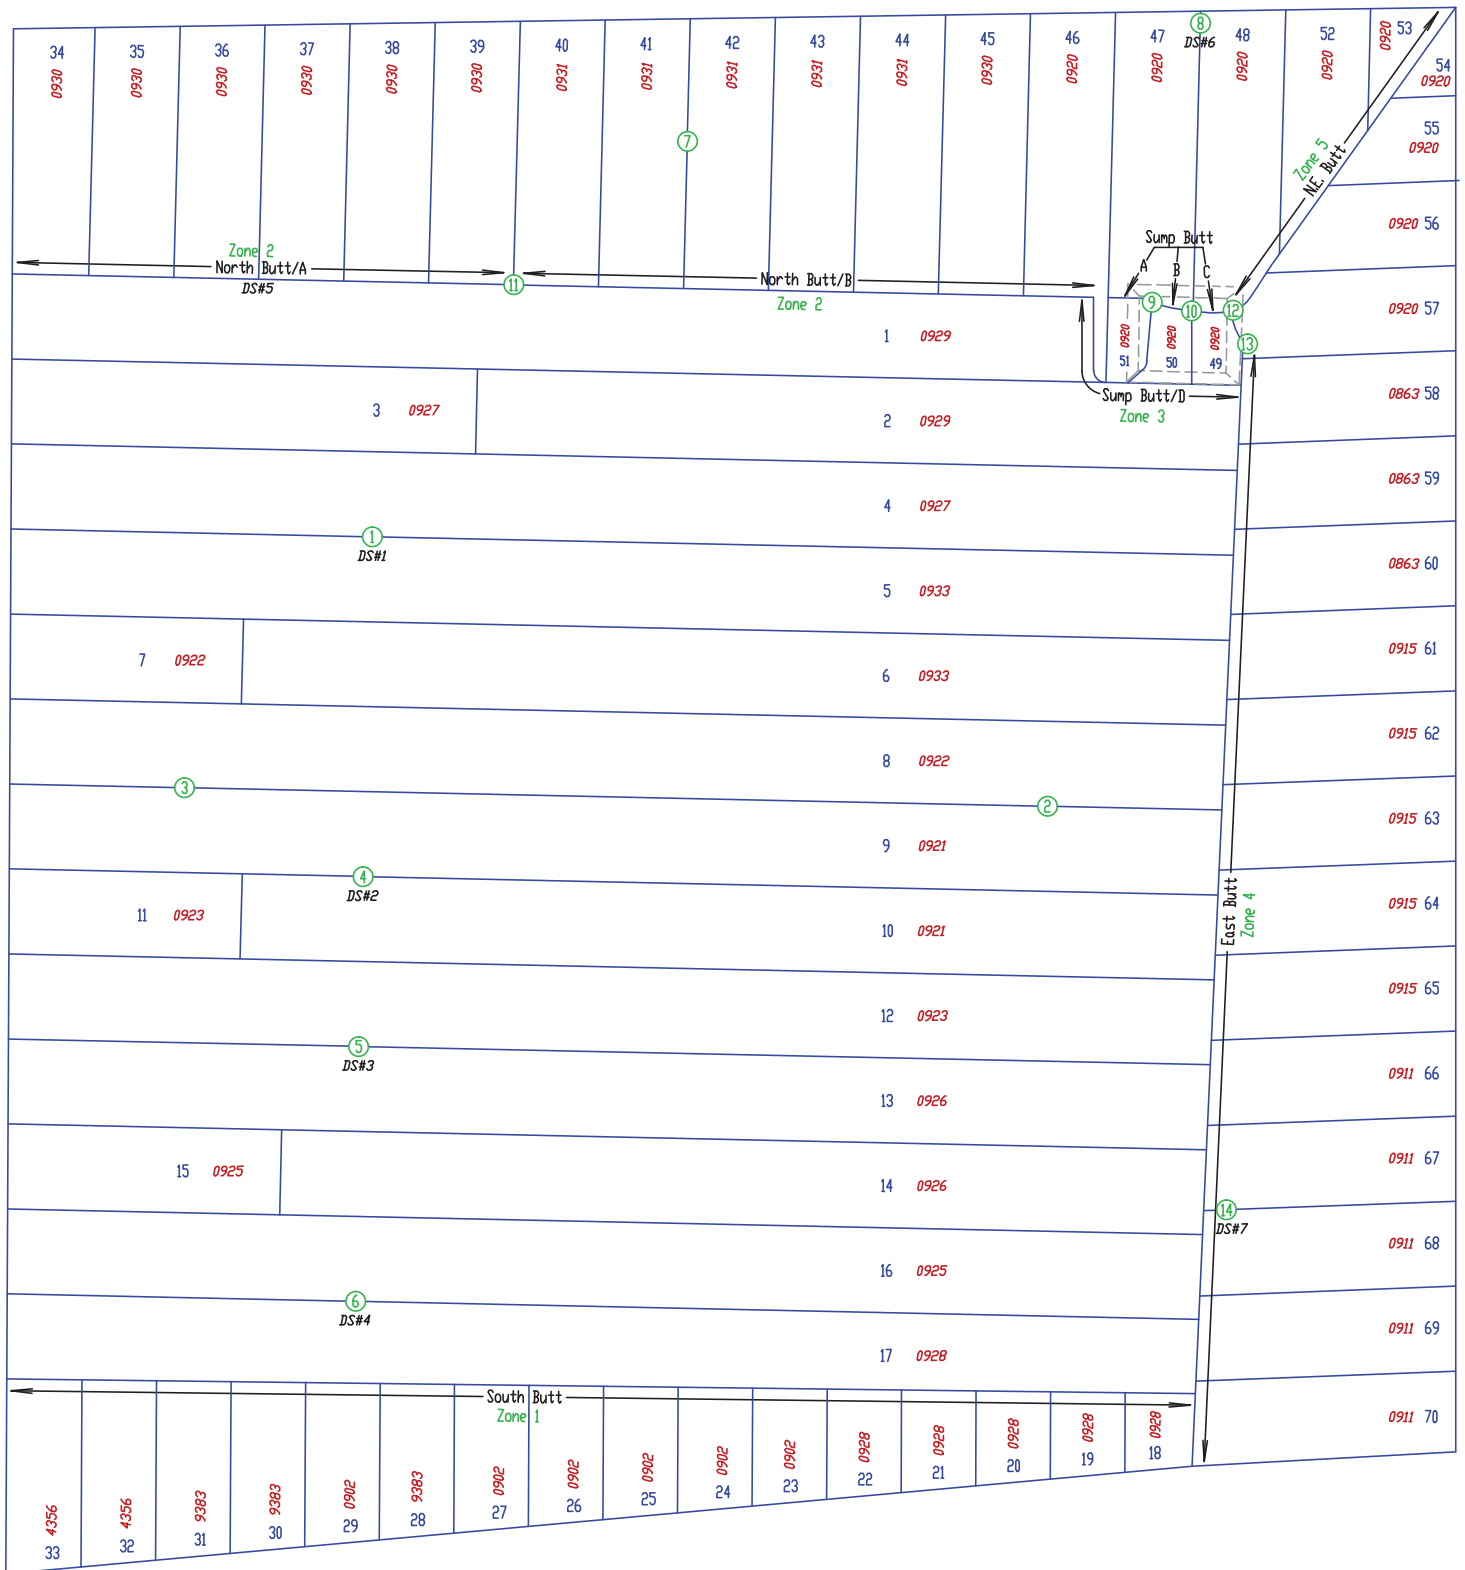
SECONDARY LINER

EXTRUSION NUMBER	EXTRUSION TYPE	PANEL/SEAM NUMBER	TEST DATE	TECH INITIAL	MACHINE NUMBER	QC INITIAL	PASS/ FAIL	COMMENTS:
	Extruded August 9th							
1	Patch	4/5	Aug 9, 2021	JC	X2	RC	Pass	Destruct #1.
	Extruded August 10th							
2	Patch	8/9	Aug 10, 2021	JC	X2	RC	Pass	GCL caught in welder.
3	Patch	8/9	Aug 10, 2021	JC	X2	RC	Pass	GCL caught in welder.
4	Patch	9/10	Aug 10, 2021	JC	X2	RC	Pass	Destruct #2.
5	Patch	12/13	Aug 10, 2021	JC	X2	RC	Pass	Destruct #3.
6	Patch	16/17	Aug 10, 2021	JC	X2	RC	Pass	Destruct #4.
	Extruded August 11th							
Zone 1	Beads	S.Butt	Aug 11, 2021	JC	X2	MC	Pass	All "T" Intersections along South Butt.
	Extruded August 14th							
7	Patch	41/42	Aug 14, 2021	MC	X2	CC	Pass	Welder stalled midway up slope.
8	Patch	47/48	Aug 14, 2021	MC	X2	CC	Pass	Destruct #6.
9	Patch	50/51	Aug 14, 2021	MC	X2	CC	Pass	In Sump.
10	Patch	49/50	Aug 14, 2021	MC	X2	CC	Pass	In Sump.
11	Patch	N.Butt	Aug 14, 2021	MC	X2	CC	Pass	At Seam 39/40.

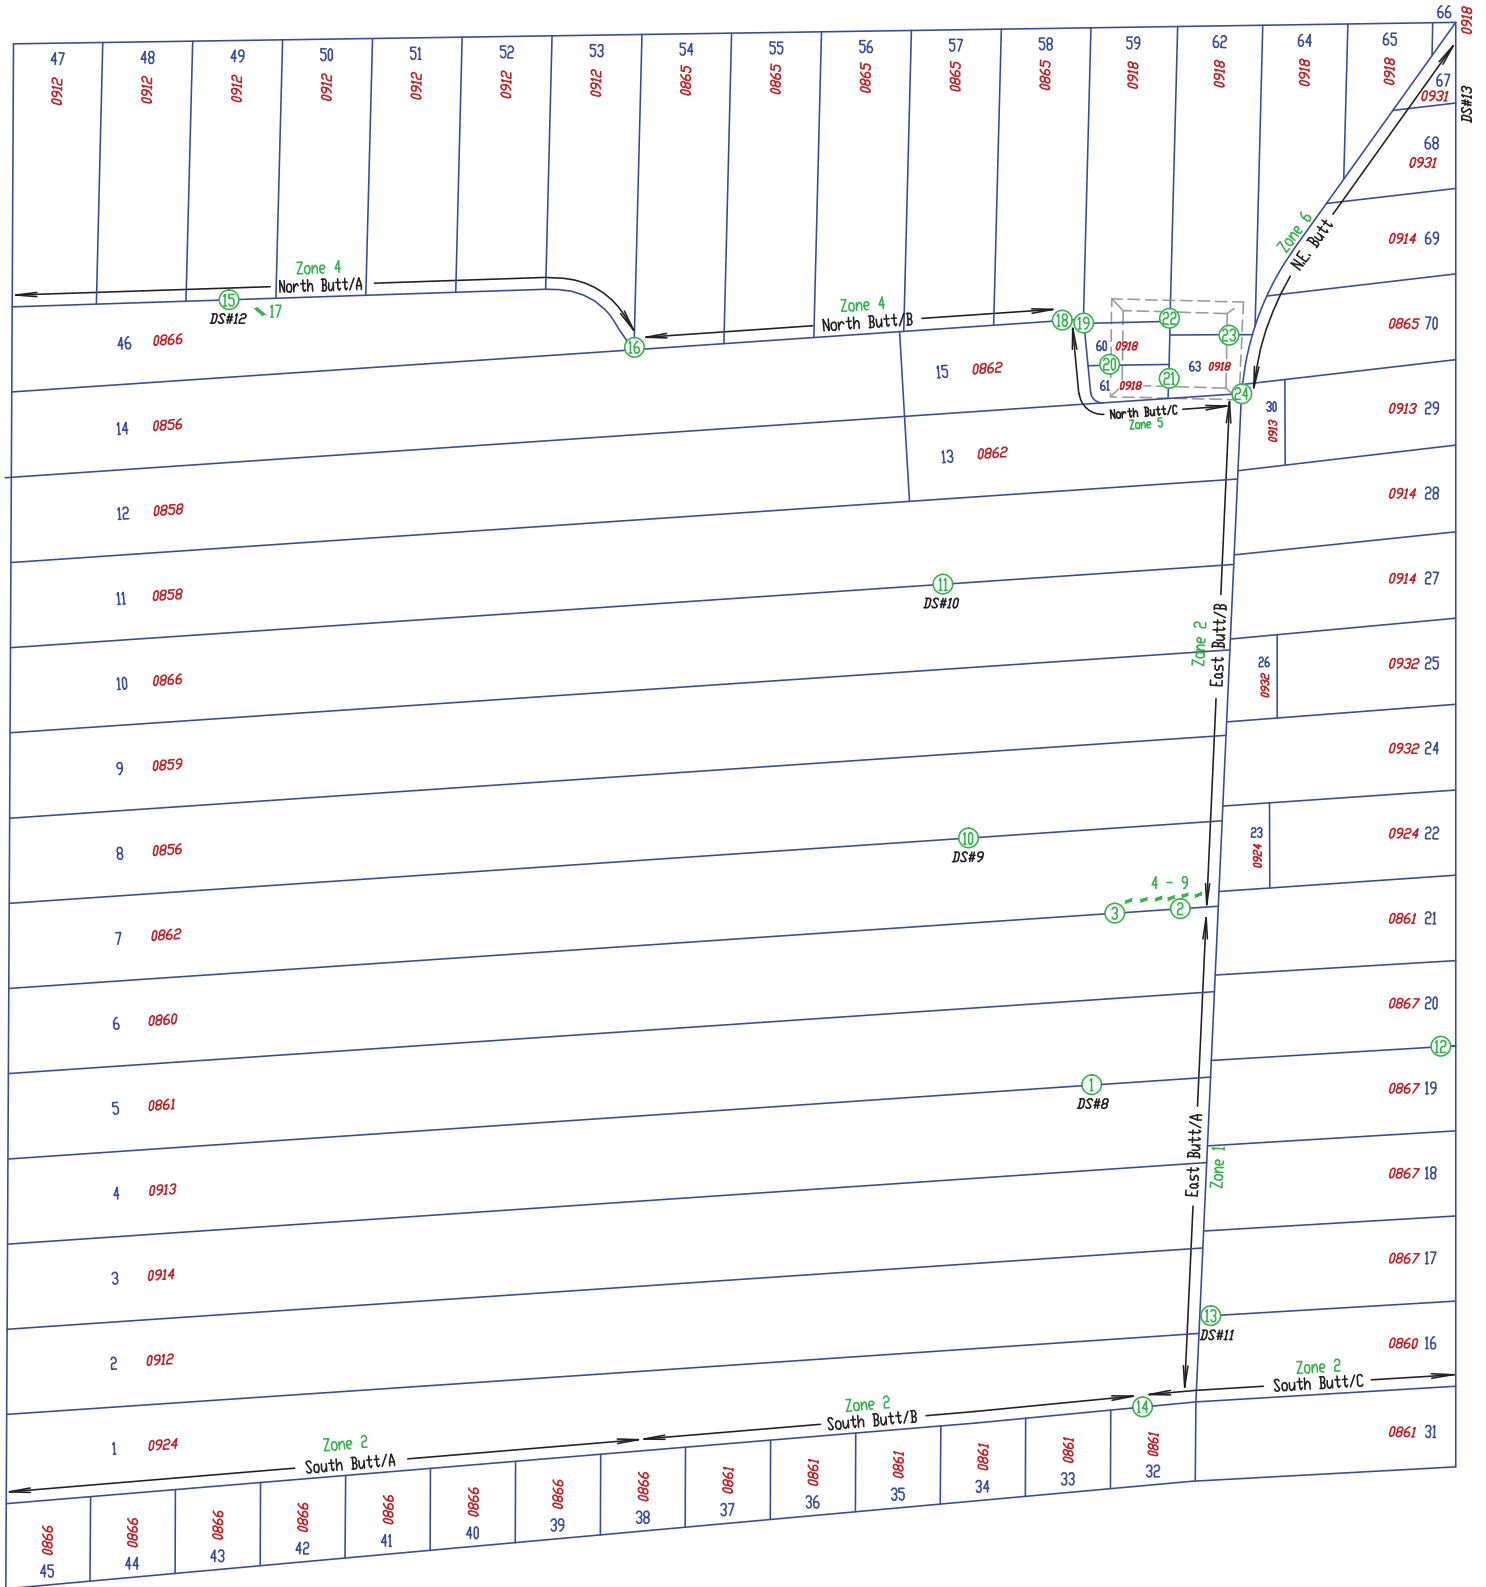
NORTHWIN LANDFILL CELL 1
PRIMARY LINER

EXTRUSION NUMBER	EXTRUSION TYPE	PANEL/SEAM NUMBER	TEST DATE	TECH INITIAL	MACHINE NUMBER	QC INITIAL	PASS/ FAIL	COMMENTS:
Extruded August 18th								
1	Patch	4/5	Aug 18, 2021	MC	X2	CC	Pass	Destruct #8.
2	Patch	6/7	Aug 18, 2021	MC	X2	CC	Pass	Burn Out.
3	Patch	6/7	Aug 18, 2021	MC	X2	CC	Pass	Burn Out.
4	Bead	7	Aug 18, 2021	MC	X2	CC	Pass	Roll Damage.
5	Bead	7	Aug 18, 2021	MC	X2	CC	Pass	Roll Damage.
6	Bead	7	Aug 18, 2021	MC	X2	CC	Pass	Roll Damage.
7	Bead	7	Aug 18, 2021	MC	X2	CC	Pass	Roll Damage.
8	Bead	7	Aug 18, 2021	MC	X2	CC	Pass	Roll Damage.
9	Bead	7	Aug 18, 2021	MC	X2	CC	Pass	Roll Damage.
Extruded August 20th								
10	Patch	7/8	Aug 20, 2021	MC	X2	CC	Pass	Destruct #9.
11	Patch	10/11	Aug 20, 2021	MC	X2	CC	Pass	Destruct #10.
12	Patch	19/20	Aug 20, 2021	MC	X2	CC	Pass	Burn out Crest of slope.
Zone 1	Beads	E.Butt/A	Aug 20, 2021	MC	X2	CC	Pass	All "T" Intersections along E.Butt/A.
Extruded August 21st								
13	Patch	16/17	Aug 21, 2021	JC	X2	RC	Pass	Destruct #11.

EXTRUSION NUMBER	EXTRUSION TYPE	PANEL/SEAM NUMBER	TEST DATE	TECH INITIAL	MACHINE NUMBER	QC INITIAL	PASS/ FAIL	COMMENTS:
Extruded August 24th								
15	Patch	46/49	Aug 24, 2021	JC	X2	RC	Pass	Destruct #12.
16	Patch	N.Butt	Aug 24, 2021	JC	X2	RC	Pass	Start/Stop at Seam 53/54.
17	Bead	46	Aug 24, 2021	JC	X2	RC	Pass	Near Panel 49.
Zone 4	Beads	N.Butt/A&B	Aug 24, 2021	JC	X2	RC	Pass	All "T" Intersections along N.Butt/A and B.
Extruded August 25th								
18	Patch	N.Butt/B	Aug 25, 2021	JC	X2	RC	Pass	Start/Stop at Panel 58.
19	Patch	58/59	Aug 25, 2021	JC	X2	RC	Pass	At N.W. Corner of Sump.
20	Patch	60/61	Aug 25, 2021	JC	X2	RC	Pass	Fit Liner in Sump area.
21	Patch	61/63	Aug 25, 2021	JC	X2	RC	Pass	Fit Liner in Sump area.
22	Patch	59/62	Aug 25, 2021	JC	X2	RC	Pass	Fit Liner in Sump area.
23	Patch	62/63	Aug 25, 2021	JC	X2	RC	Pass	Fit Liner in Sump area.
24	Patch	E.Butt/B	Aug 25, 2021	JC	X2	RC	Pass	Start/Stop between E.Butt/B and N.E.Butt.
